# New Home Building Inspections

## Pre Handover

Inspection Date: 2 Feb 2024

Property Address: 26 Not Fit For Handover Dream Suburb 44444

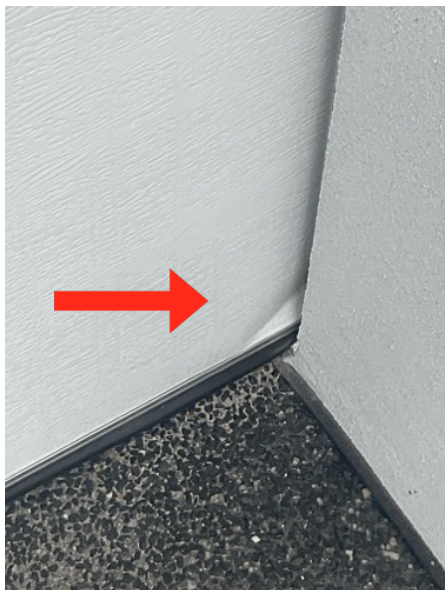
### Defect 1.01

**Finding:** Damaged materials observed. ( garage door )

During our inspection we identified materials that have been damaged, as detailed in the photos below.

As part of the contract the builder has with you, the builder must ensure all materials are new & fit for purpose. The builder needs to attend to the damaged item/s in question, (detailed below) and replace the item/s with new.

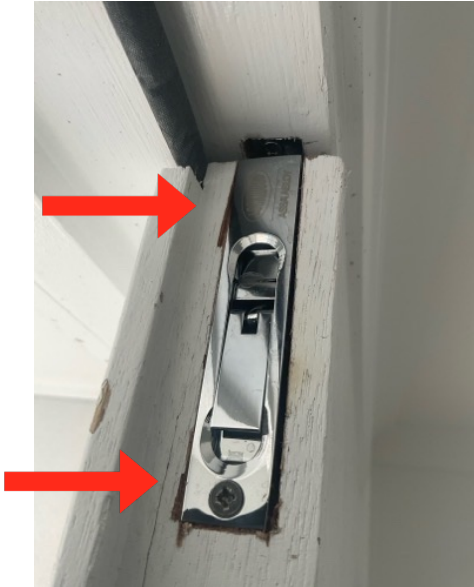
## Defect 1.02

**Finding:** Door -lock poorly installed

The locks to this door is misaligned and has consequently resulted in the doors operation being compromised. This is a common defect whether being due to substandard installation or general miss alignment of the door hardware. Re installation of the hardware is recommended.

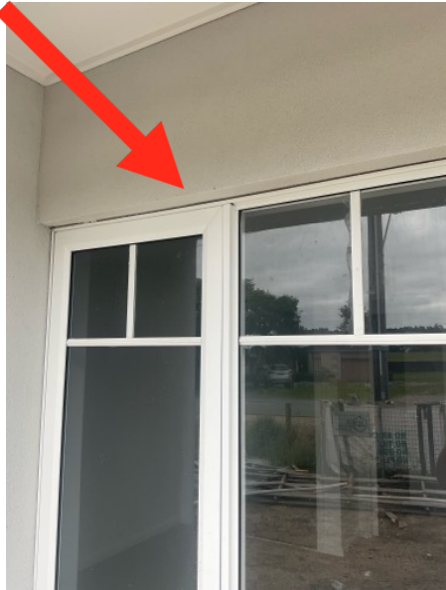
## Defect 1.03

The gaps between must be filled, in accordance with Australian standard.

The current gap is allowing a volume of air to enter the dwelling. BCA 3.12.3.3, in addition to relevant Australian Standards, also calls for all gaps around windows and doors and general cladding to be sealed.

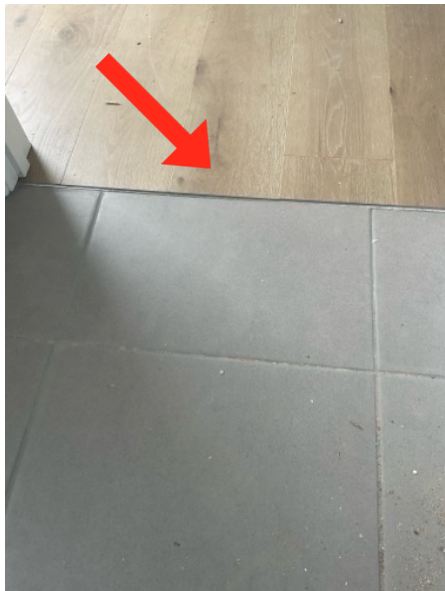
## Defect 1.04

**Finding:** Stepping between floors

There is a noticeable height difference observed between floor levels. It appears the timber floor is bowed to section as per photography below.

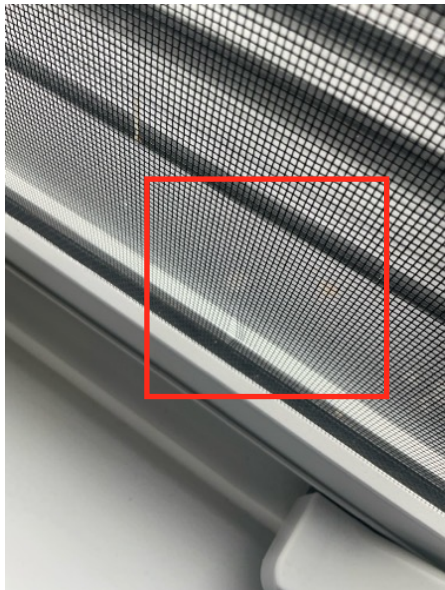
## Defect 1.05

**Finding:** Fly screen damaged.

As per documented photos area as per below requires replacement.

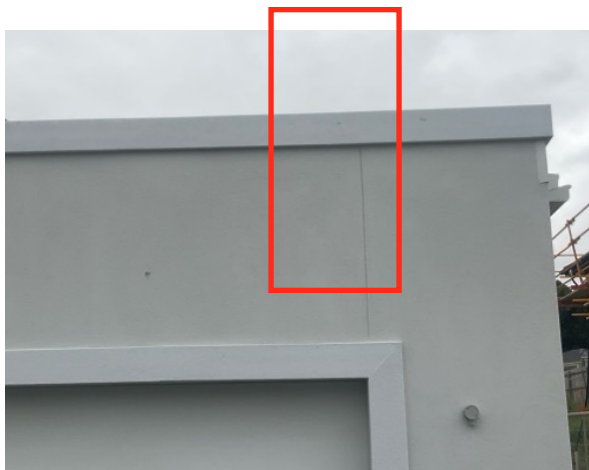
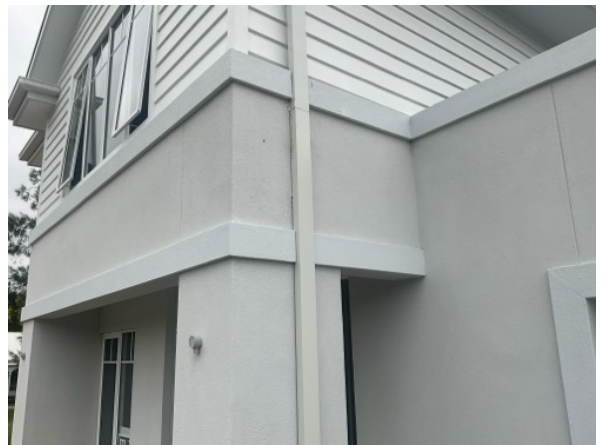
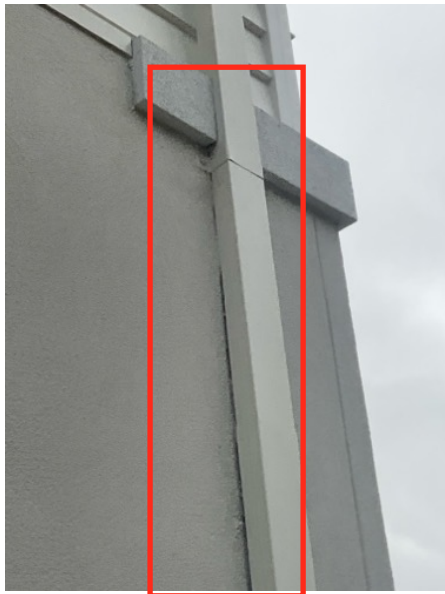
## Defect 1.07

Some substandard practices observed to the exterior render of this home, The general render has not been applied in accordance with the contract documents, which looks poorly finished, and detracts from the overall finish.

The Victorian Building Authority's Guide to Standards and Tolerances clause (9.09) Rendered surfaces, states that Rendered or hard plastered surfaces are defective if they do not conform to the documented surface, sample or description.

In order for the builder to reach completion, they must have completed the works in a proper and workmanlike manner and in accordance with the plans and specifications. Therefore, these areas must be rendered to match the contract documents in accordance with above. Photos added below show some areas for rectification works. The entire property should be checked by the builder.

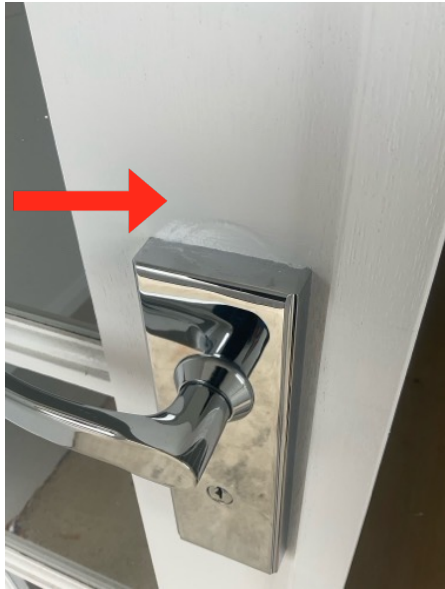
## Defect 1.08

As documented in the photographs below, there are materials presenting with damage. All materials used to build this dwelling must present as new in accordance with the building Act section 137, part 9. Further works or replacement required, unless stated otherwise in the build contract.

I refer to the Building Act Section 137.

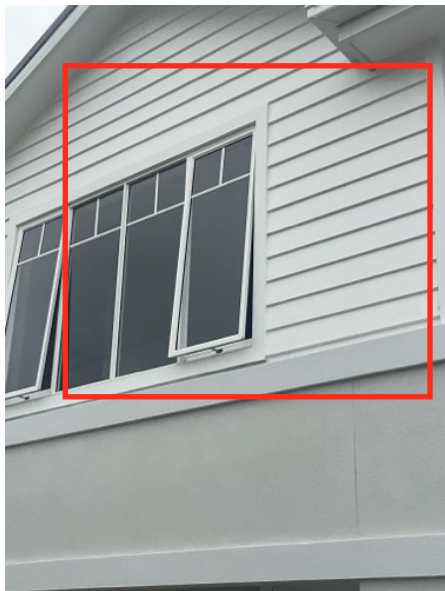
## Defect 1.10

Painting is considered defective if blemishes can be seen with non-critical light and from a normal viewing position.

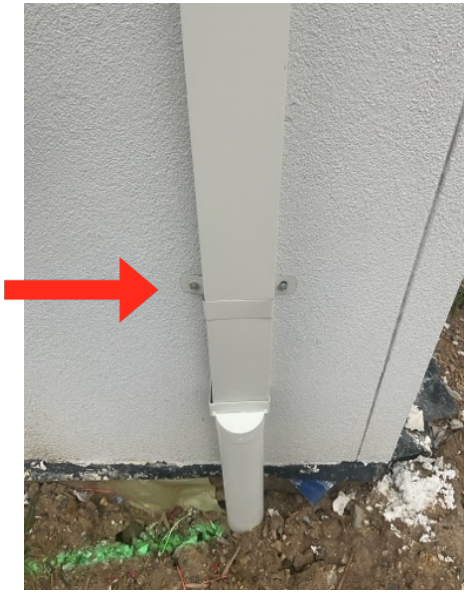
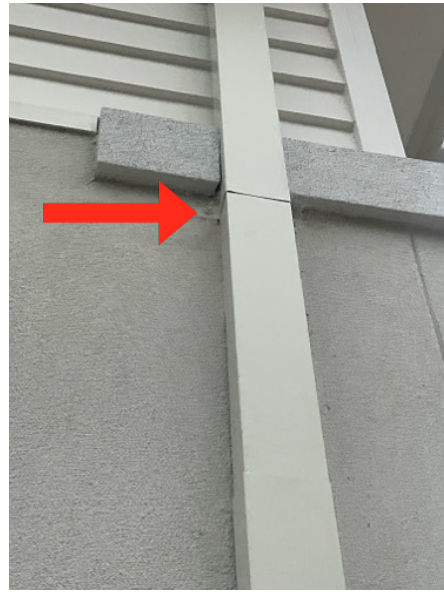
## Defect 1.11

Noted fixings differ in colour to downpipes areas.

Gutters and downpipes are defective if they are not securely fixed.

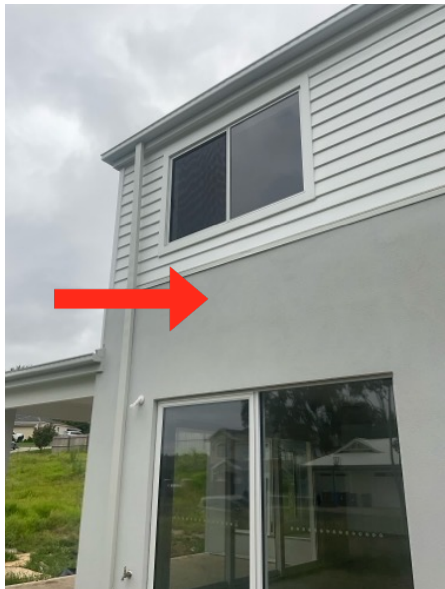
## Defect 1.12

**Finding:** Flashing repairs required ( damaged)

The flashings are showing signs of damage in areas.  
Gutters and downpipes and general flashings are defective if they are not securely fixed or misalignment or damage can be seen from normal viewing position. As per documented photos below area requires replacement.

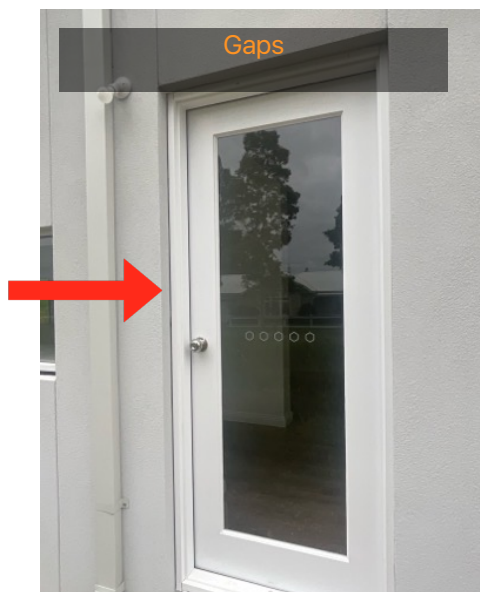
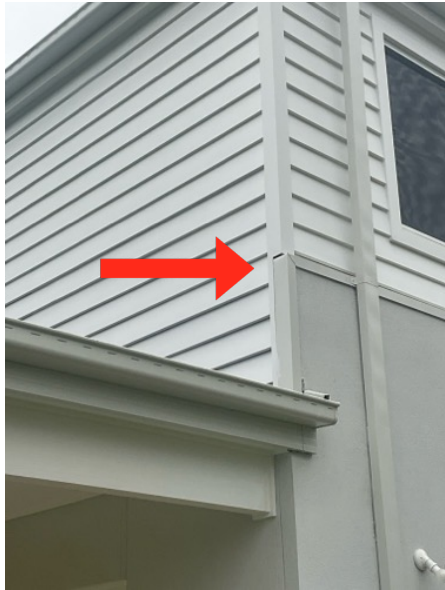
## Defect 1.13

Ceilings, walls, floors, and any opening such as a window frame, door frame, roof light frame or the like must be constructed to minimise air leakage in accordance with (b) when forming part of the external fabric of –

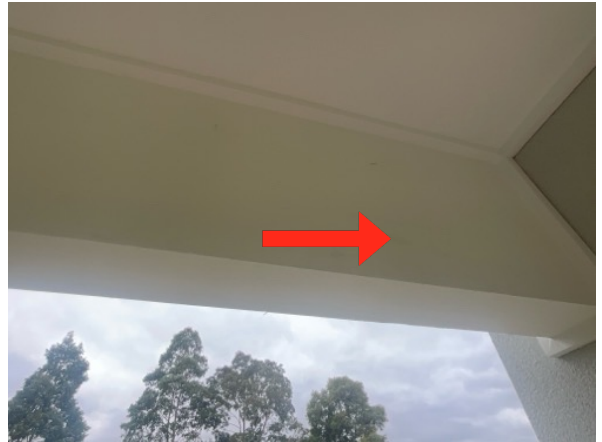
## Defect 1.14

The Building Commission's Guide to Standards and Tolerances clause 12.04 Mechanical Damage and Natural Defects in Surfaces, states 'Holes and any other unfilled depressions in paint or stained timber such as surface defects caused by mechanical damage, natural characteristics such as gum pockets or surface splits are defects if they can be seen from a normal viewing position'. A normal viewing position would be at a distance of 1.5 metres or greater back from these beams.

The splits and holes along these beams need to be properly filled before being properly sanded and repainted prior to handover proceeding.

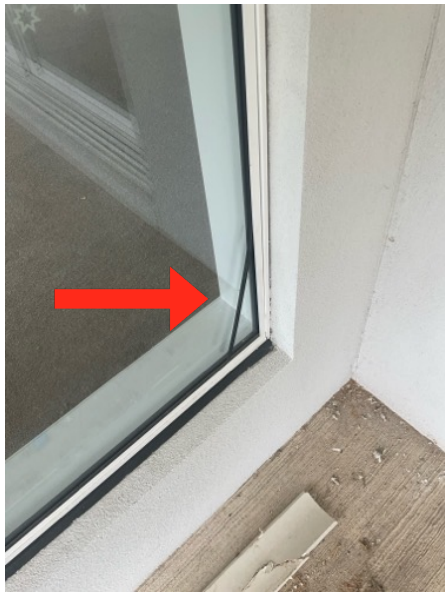
## Defect 1.15

To some windows of the property, the Window Rubbers did not cover the full length of the opening, In these locations the builder will need to ensure the building is sealed correctly to prevent water or moisture penetration.

The gap shall be sealed with suitable flexible mouldings or flexible caulking to resist water penetration, or other weatherproofing methods shall be used.

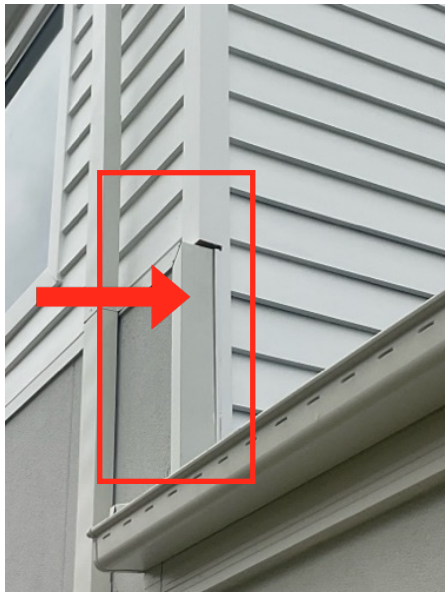
## Defect 1.16

**Finding:** General workmanship

Area observed requires rectification. The builder warrants that the work will be carried out in a proper and workmanlike manner, and with reasonable care and skill, which is not the case in this area, and should be repaired or reconstructed. Areas shown in documented photos below.

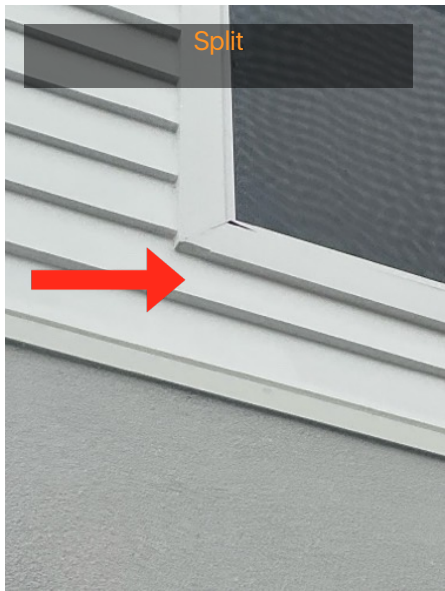
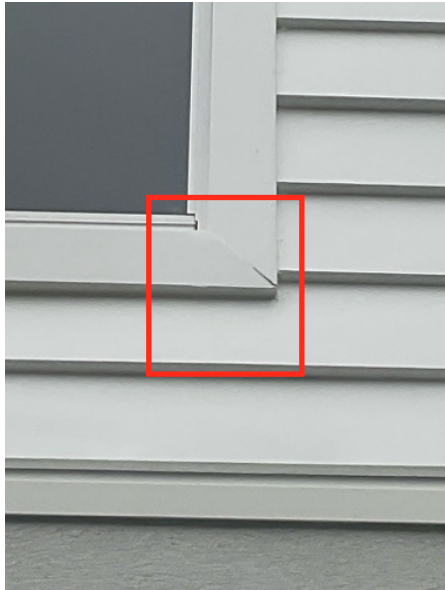
## Defect 1.17

(17.3. )The guide to standards and tolerances 2015,10.02 Joints in fixings and mouldings states:

“Unless documented otherwise, the faces of architraves and skirtings are defective if they are not aligned and flush at mitres and butt joints and the misalignment can be seen from a normal viewing position. (These areas will require rectification.)

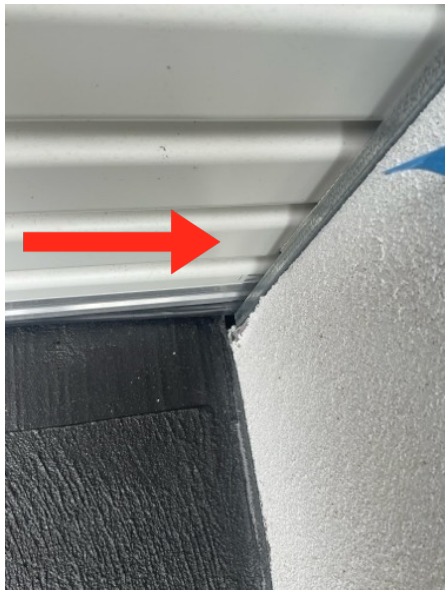
## Defect 1.18

1/ The powder coat finish to this aluminium frame has been damaged through the finished coating. Damaged powder coat finish cannot be correctly repaired on site and may have to be replaced.

2/ Noted internal tracks to garage door not secured at time of inspection.

The damage to all aluminium frames must be made "as new" prior to handover.

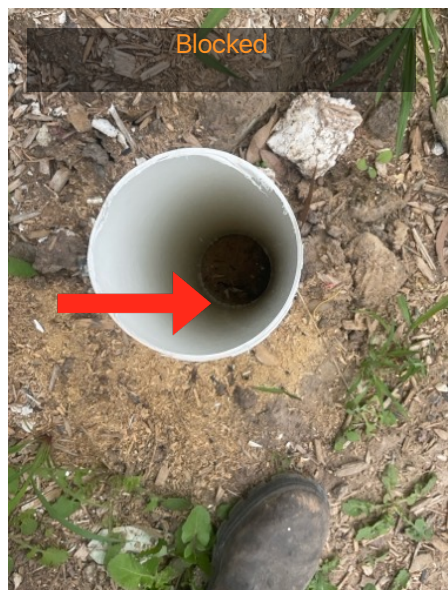
## Defect 1.19

**Finding:** Damaged pipe's requiring repair and recapping

The PVC pipes to various locations have been damaged or uncapped. These will require repair and recapping to prevent debris blocking the pipes during the construction process. Noted areas blocked with mulch etc.

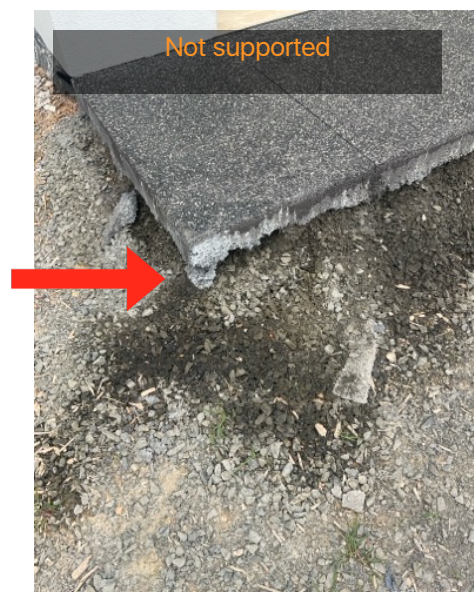
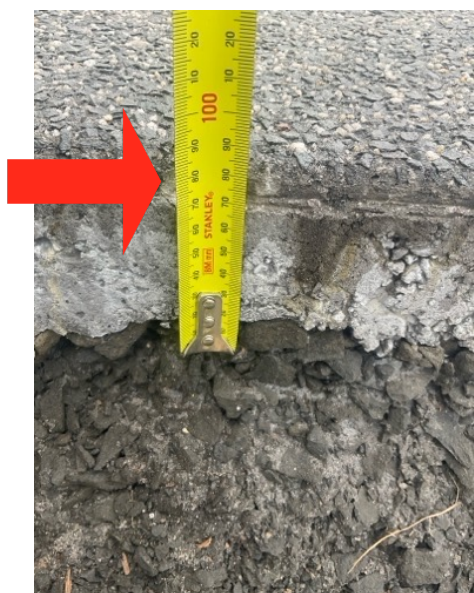
## Defect 1.20

**Location:** The site  
**Finding:** Concrete observed.

While it is not possible to confirm the site preparation of works undertaken by the Builder prior to pouring, the sub-base to the driveway area. While appearing adequate for typical lightweight residential construction, it should be to the requirements of AS3727.1 2016. Noted areas not achieving 100mm. Some areas appear to have little or no support.

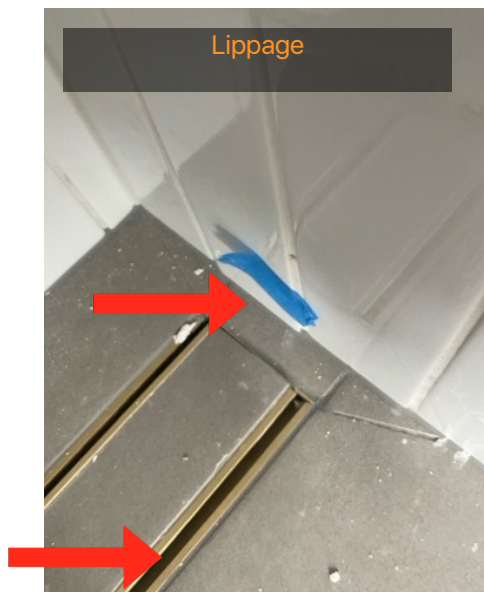
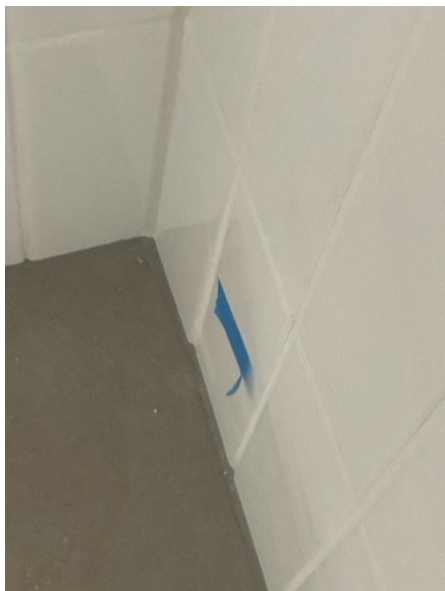
## Defect 1.21

When measured with a straightedge, tiling is defective if the finished surface of the tiling is not flat and true to within a tolerance of  $\pm 4$  mm in 2m from the required plane.

Tiling is defective if the lippage between two adjacent tiles exceeds 2 mm. In the case of tiles where the surface has been ground flat, for example polished tiles, tiling is defective if the lippage exceeds 1.5 mm; for joint widths of 3 mm or less the lippage should not exceed 1 mm.

As per AS 3958.1, lippage must be restricted to 1 mm maximum. We detected tiles that need to be reworked as the lippage exceeds this allowance. Any tile with a lippage that is greater than 1 mm must be reworked

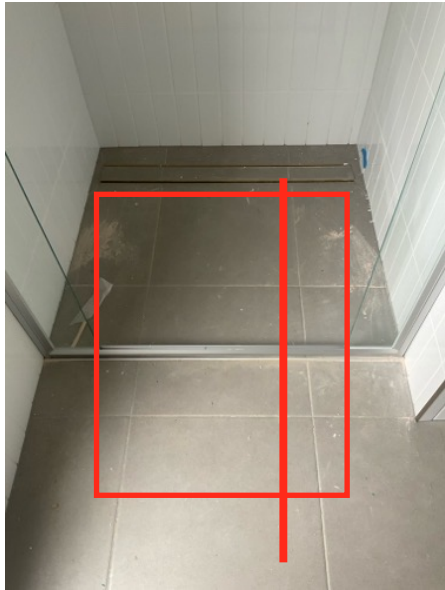
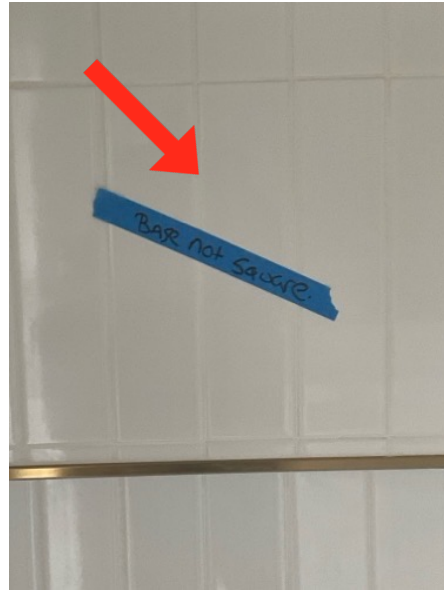
## Defect 1.22

Uneven tiling observed. It appears the shower area has been laid out of square resulting in inconsistent tiling to areas. The tiles do not line through.

Except where tiles have distortions inherent in the manufacture, tiling is defective if it has joints that are not uniform, of even width, aligned or in the same plane. Large tiles could present problems when required to fall and drain to a floor outlet.

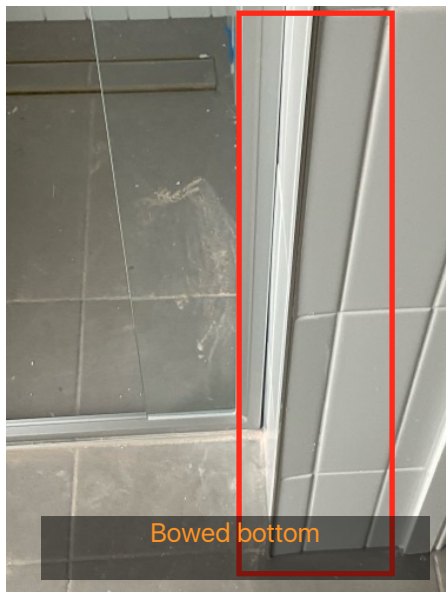
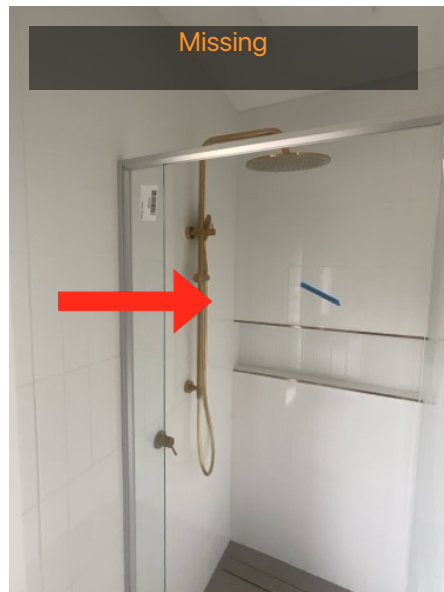
## Defect 1.23

**Finding:** Grout/ sealant - Missing shower screens incomplete.

Grout/ sealant is missing in this area. Grout or sealant is used to ensure that tiled areas are water-tight and prevent water penetration to the associated structures. Where grout or sealant is missing, a tiling contractor should be appointed immediately to apply where necessary. Failure to do so is likely to lead to water damage to the surrounding area. Noted lower wall section bowed. General rectification works required.

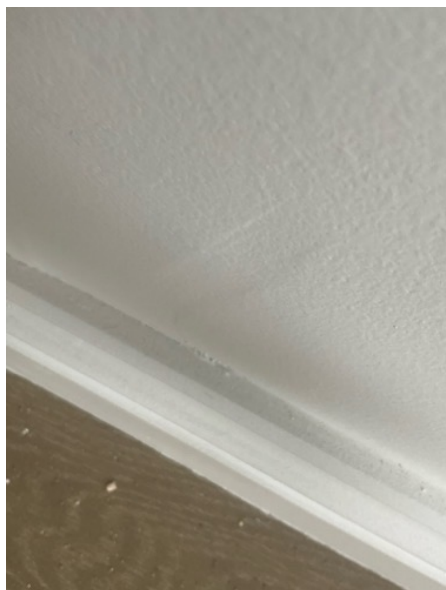
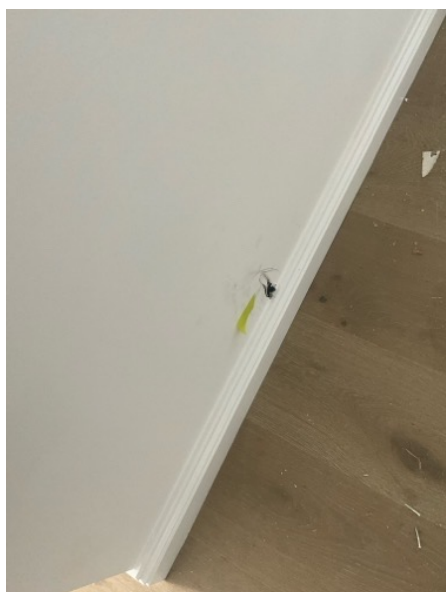
## Defect 1.24

There are numerous minor paint defects such as runs, bare areas, cracks, marks and other irregularities that need to be rectified throughout, too many to individually document in this report.

The Victorian Building Authority's Guide to Standards and Tolerances clause 12.02 Surface Finish of Paintwork, states Paintwork is defective if application defects or blemishes such as paint runs, paint sags, wrinkling, dust, bare or starved painted areas, colour variation, surface cracks, irregular and coarse brush marks, sanding marks, blistering, uniformity of gloss level and other irregularities in the surface are visible from a normal viewing position.

All of these areas will need to be properly rectified and re-painted.

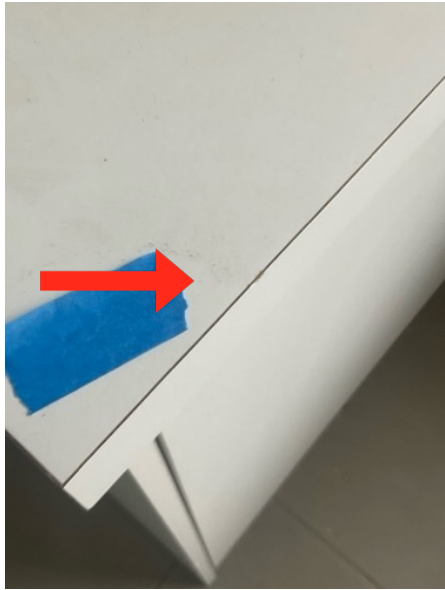
## Defect 1.25

Area as per documented photos, defective. Materials are defective if they are cracked, pitted, chipped, scratched or loose at handover.

Noted chip to bench top.

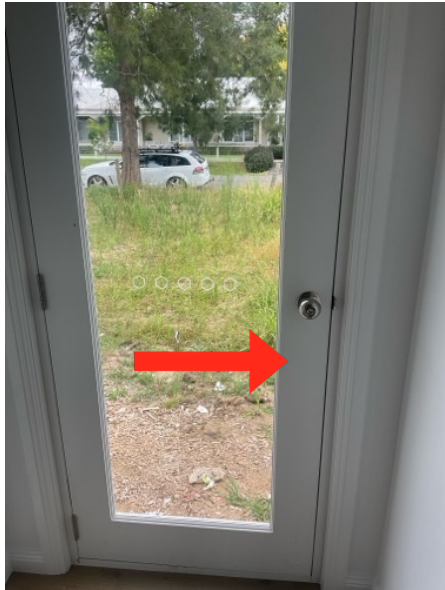
## Defect 1.26

Doors (external) - Gaps and / or seals defective

Seals required to the 3 sides of the door frame and a bottom seal to the door as well

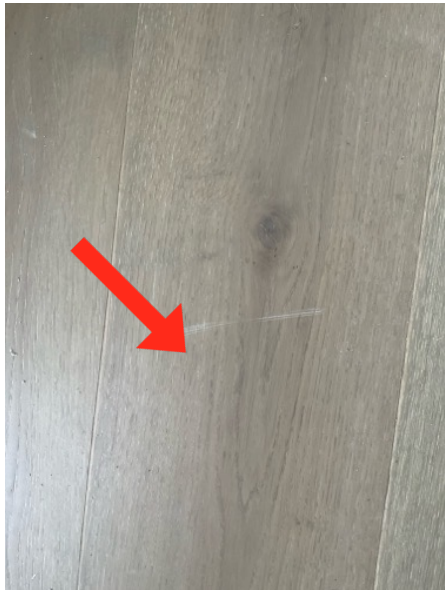
## Defect 1.27

Cracked, pitted, chipped, scratched surfaces

Noted floor not clean at time of inspection. Noted scratches observed to surface.

Surfaces are defective if they are cracked, pitted, chipped, scratched or loose at handover.

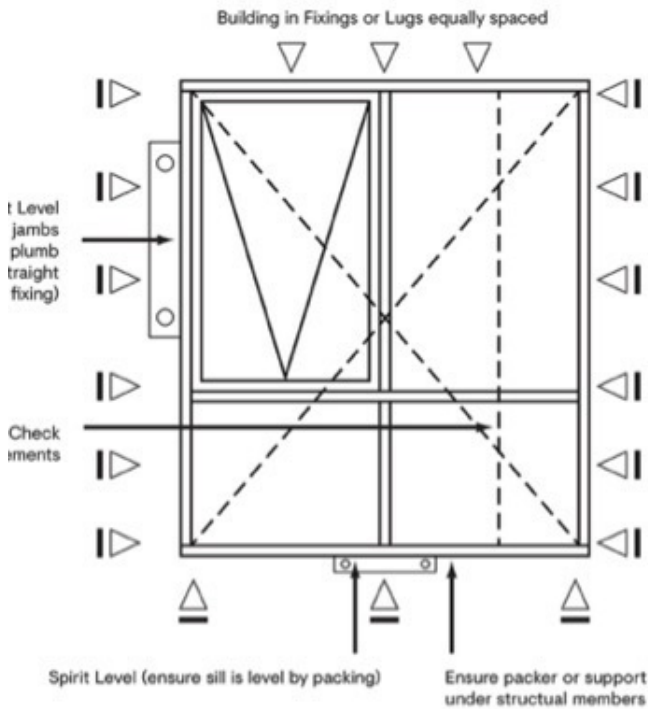
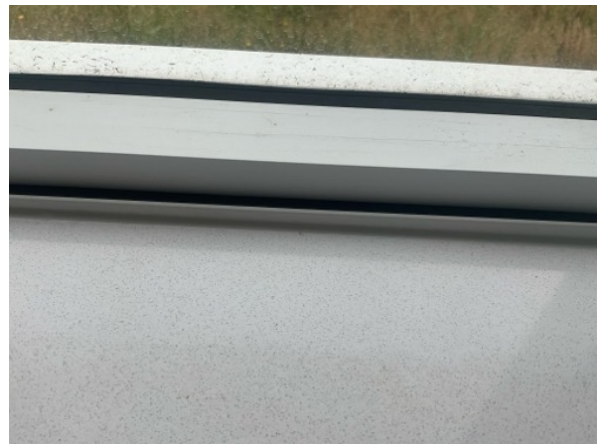
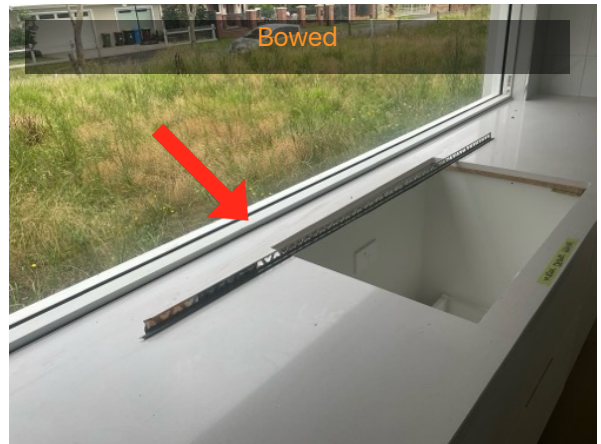
## Defect 1.28

In this case the defect in discussion is windows are bowed .

ALL WINDOWS should be installed as per manufacturers standards is packing to the sides and bottom of the windows as well, must be reworked to allow a recommended of at least 15mm to 20mm of packing.

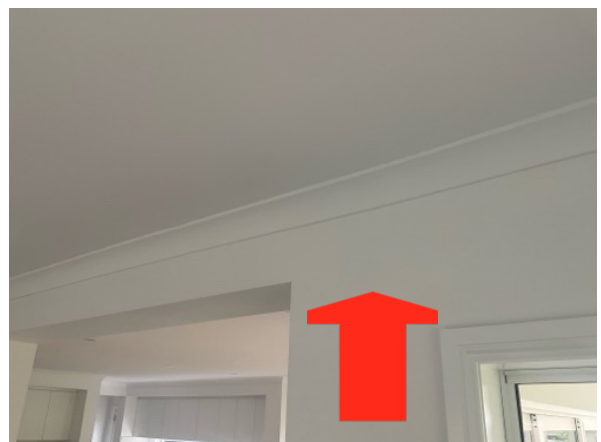
## Defect 1.29

The cornice ceiling line bowed to, section as per documented photos below.  
( AS PER ALL PREVIOUS REPORTS.) Plaster cornices are defective if they deviate from a straight line greater than 4 mm over a length of up to 2 m and are visible from a normal viewing position. There is a sag of up to 10mm in the ceiling and cornice lines across the area which is also noticeably out of parallel to the horizontal edge of this area which for the reasons detailed above will need to be properly straightened and the affected areas repaired.

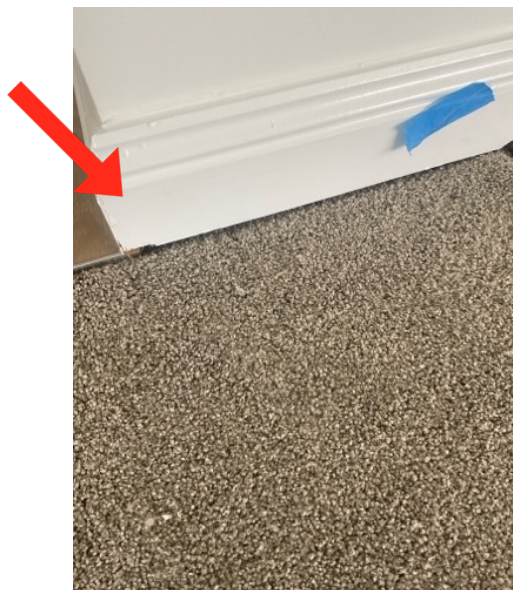
## Defect 1.30

"Unless documented otherwise, the faces of architraves and skirtings are defective if they are not aligned and flush at mitres and butt joints and the misalignment can be seen from a normal viewing position. These areas will require rectification.

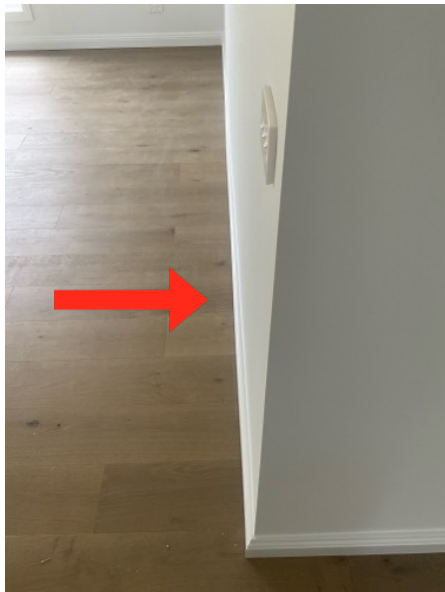
## Defect 1.31

The Victorian Building Authority's Guide to Standards and Tolerances clause (9.02) Straightness of Internal and External Wall Surfaces, states that Walls are defective if they deviate from plane (bow) by more than 5mm over a 1.8m straight edge. This tolerance includes internal walls with a build-up of plaster at internal and external corners of the plasterwork. Refer to Diagram E on page 13 of this Guide.

As stated, the acceptable allowance is 4 mm over 2 m. These walls will need to be reworked to ensure that the builder complies with this requirement. As per documented photos all walls require re work.

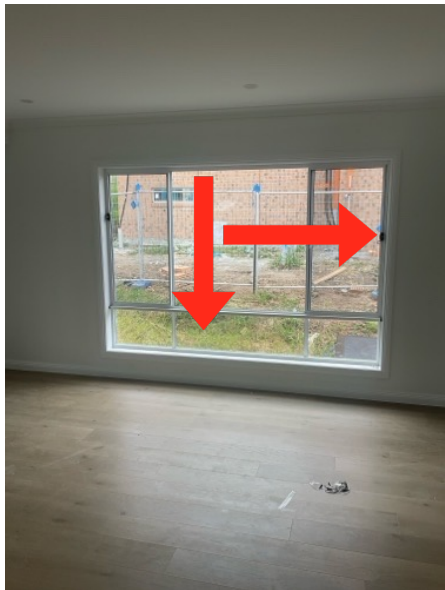
## Defect 1.32

The noted sill section is bowed as per documented photos. Bowed window heads, sills and jambs

Windows frames are defective if they are distorted to the extent that the function of the window is adversely affected.

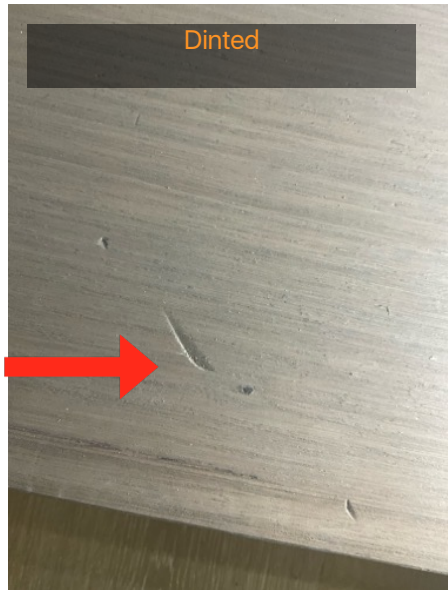
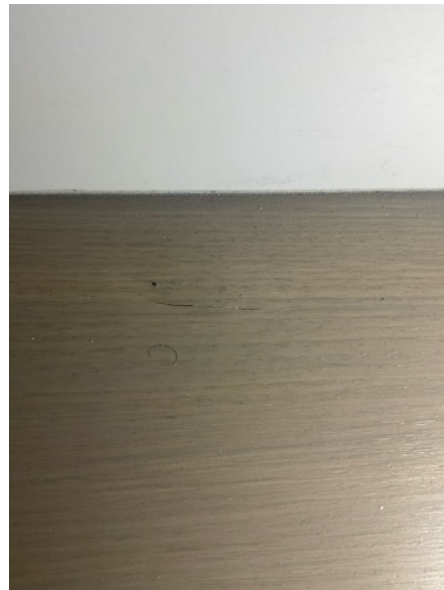
## Defect 1.33

Building elements damaged (stair treads) dented

Treads require replacement this generally occurs when the building materials have had a result of damage. Replacement of broken elements are advised to ensure that additional secondary defects do not arise as a consequence.

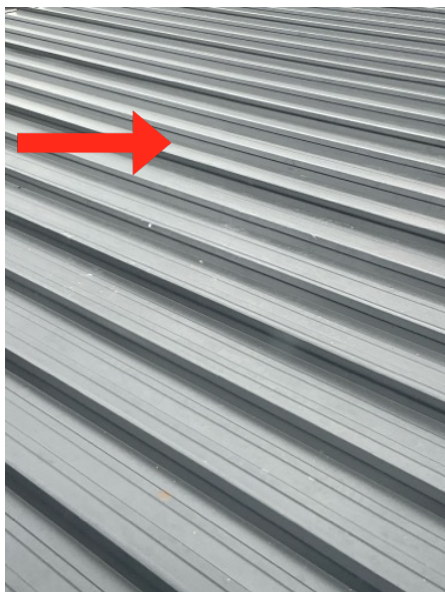
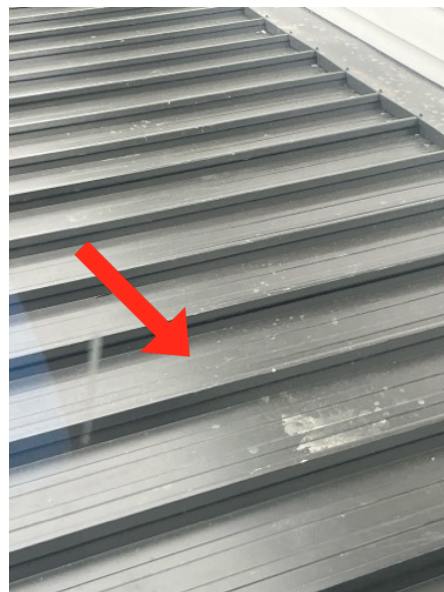
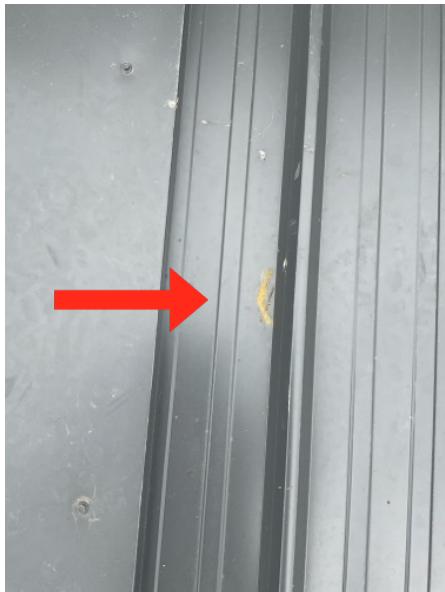
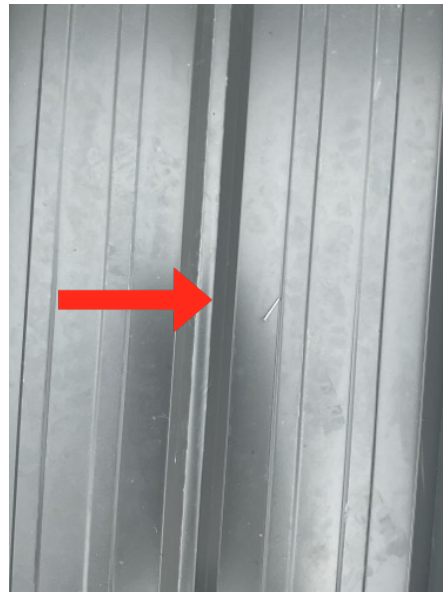
## Defect 1.34

The Victorian building Authority's Guide to Standards and Tolerances clause 18.09 Cleaning, states- 'Owners are entitled to expect that the building site and works are clean and tidy on completion. Building works are defective where windows and roof areas are not clean, floors are not swept, mopped or vacuumed as appropriate, tiles, sinks, basins, troughs, baths, etc. are not cleaned and shelving, drawers and cupboards ready for use.'

Once the cleaners have properly completed all of this work, all of the glazing, mirrors, cupboards, baths, shower bases, shower screens, floor coverings, fixtures and fitting etc. should all be thoroughly checked again for any scratches and damage which may have occurred, prior to handover proceeding.

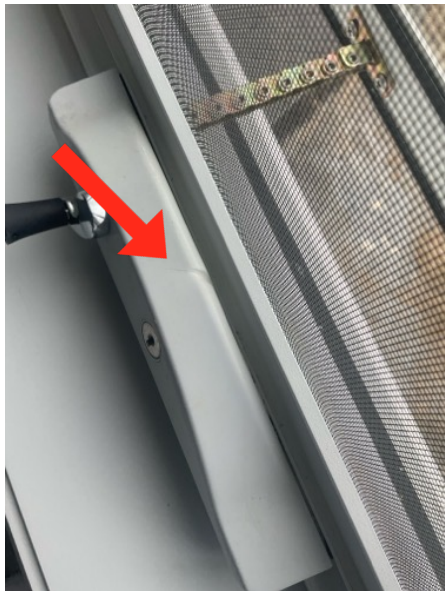
### Defect 1.35

**Finding:** Winder damaged

The product in this area was found to be damaged at the time of inspection. Replacement of the damaged product is advised.

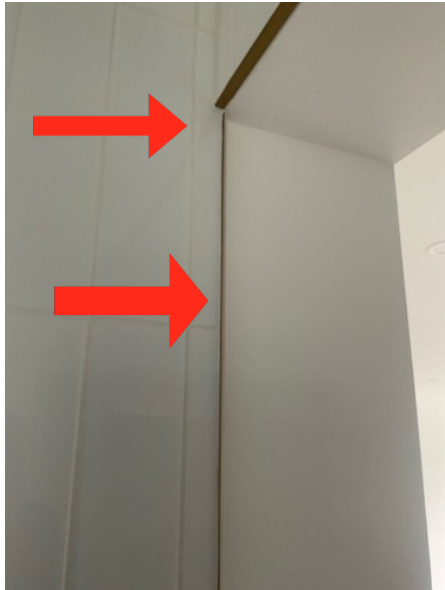
### Defect 1.36

The noted trims as per other areas protrude past the tile line. See other areas also.

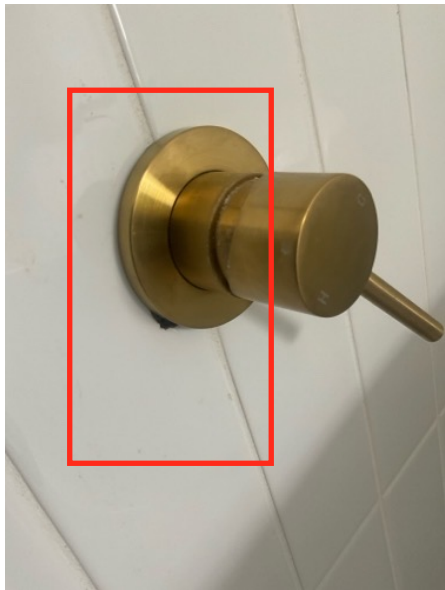
## Defect 1.37

**Finding:** Overcut tiles observed to wall lines.

If any tile is chipped, cracked, scratched or loose prior to the handover of the property the tile/s or tiling is considered defective. Noted tiles over cut to plumbing fixtures.

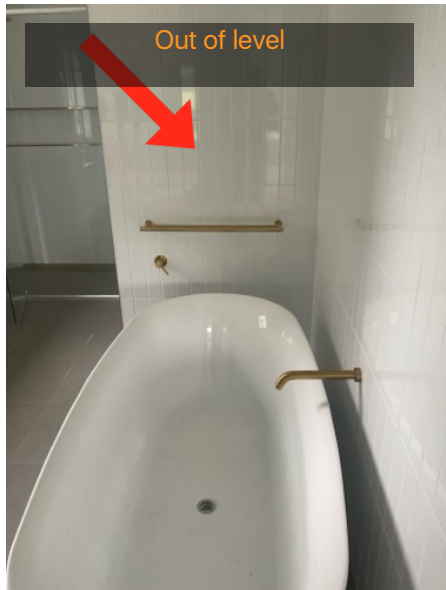
## Defect 1.38

The towel rail was found to be installed out of level at the time of inspection. It is suspected that this defect has developed due incorrect installation. Refer back to builder to appointed to re-fix the fitting.

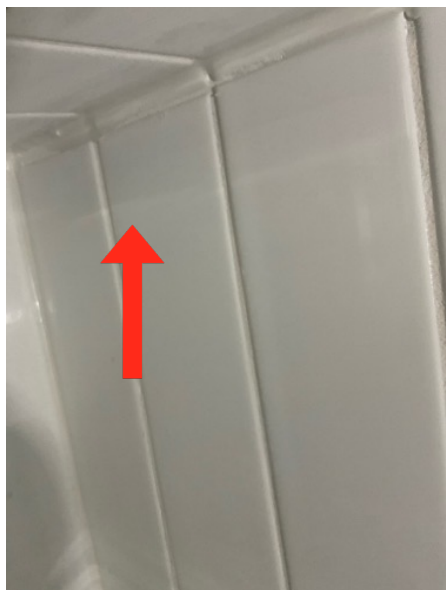
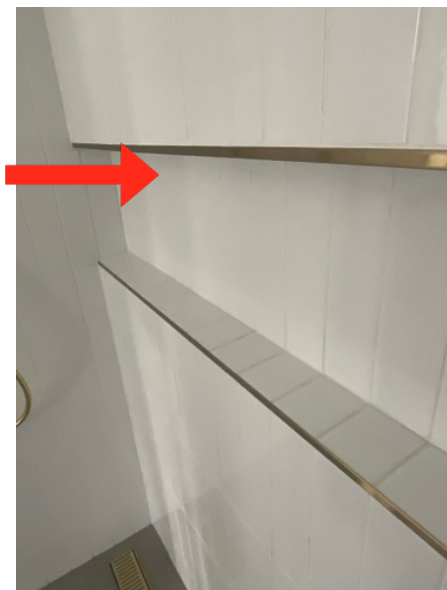
## Defect 1.40

The noted tiles to the top of the niche section appear to be out of parallel, there is an excessive caulk line to the top of the niche area.

The relevant Australian Standard A.S. 3958.1 – 2007 Ceramic Tiles – Guide to the Installation of Ceramic Tiles, clause 5.4.6 Tile Finish and Joints also states that 'Joint widths should be consistent throughout the installation unless otherwise specified. The recommended joint widths for floors with dust-pressed tiles are 3mm, measured at the tile face' and clause 5.4.3 – Fitting, states that 'Keep all joint lines, including mitres, straight and of even width'. These tiles and the grout joint widths must be properly rectified or replaced.

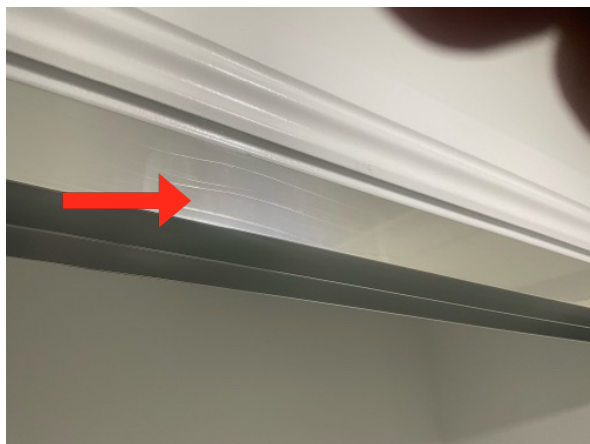
## Defect 1.41

The powder coat finish to this aluminium frame has been damaged through the finished coating. Damaged powder coat finish cannot be correctly repaired on site and may have to be replaced.

The damage to all aluminium frames must be made "as new" prior to handover.

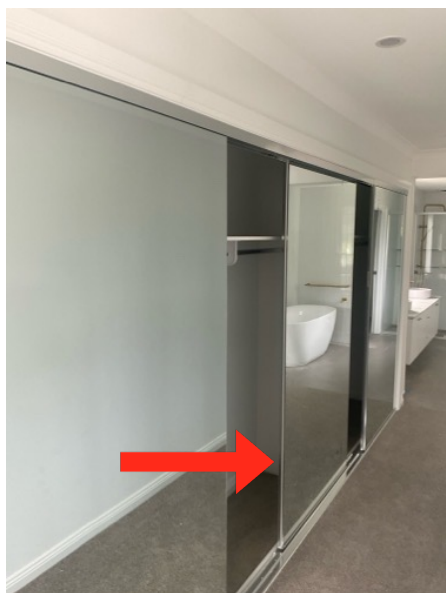
## Defect 1.42

Unless additional clearance is required for removable toilet doors or air ventilation, a clearance between the door and the floor finish is defective if it is greater than 20 mm after installation of the floor covering.

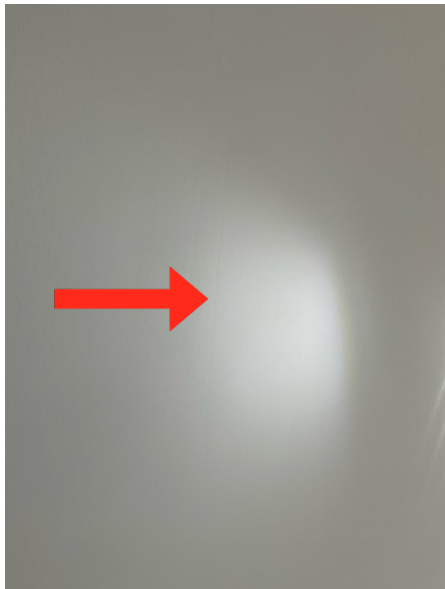
## Defect 1.43

**Finding:** Plaster defects observed ceiling area.

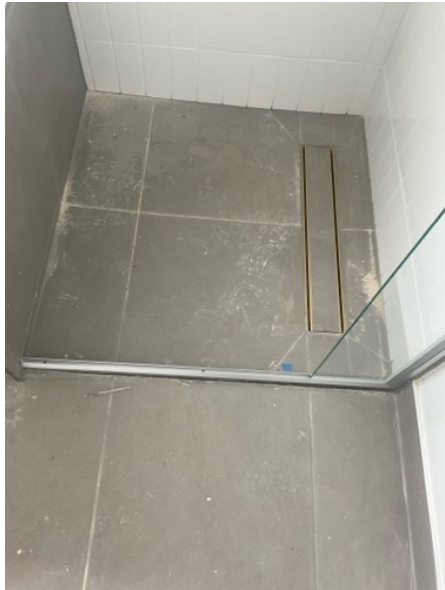
## Defect 1.44

The noted tile lines to shower waste do not line through, and are inconsistent. See photos below. Noted shower screen incomplete at time of inspection.

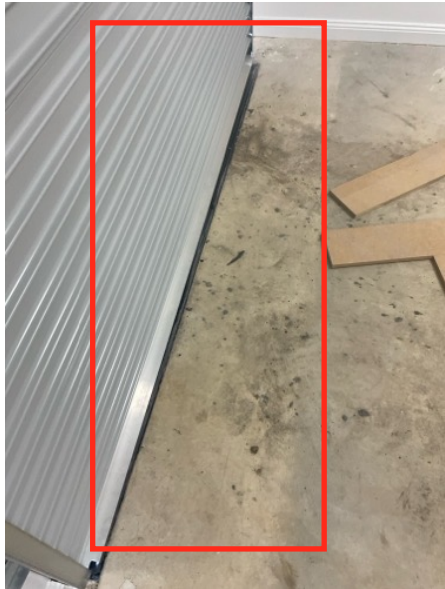
## Defect 1.45

Areas require adjustments. Noted area not closing to garage slab. Garage slab short to door section.

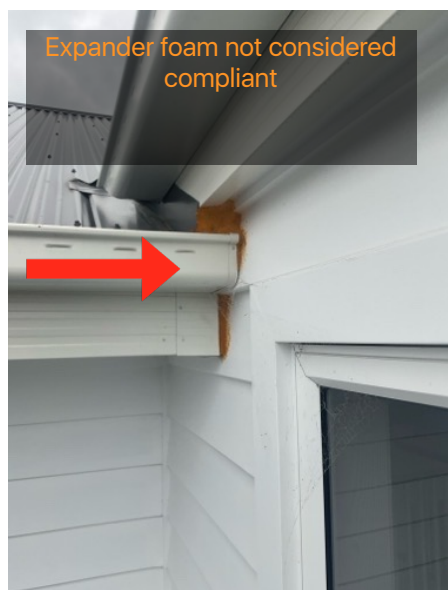
## Defect 1.46

Areas that are frequently exposed to harsh weather conditions require adequate protection in order to maintain their condition. The pieces to the sections as per documented photos is non compliant or finished adequately, general deterioration is likely to occur at an accelerated rate. If left unattended, water penetration is likely in the short-term future. Adequate flashing will be required to be installed as soon as possible.

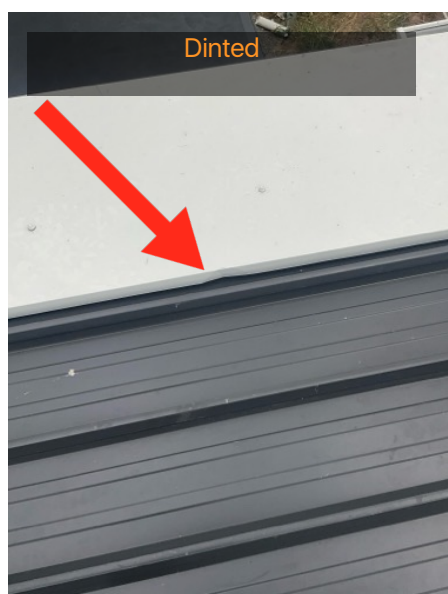
## Defect 1.47

These materials and all other debris, including blind rivet shanks, nails and screws are to be cleaned from the roof area and gutter regularly during the installation process as unsightly staining of the surface due to oxidation of the metal particles will result, leading to corrosion and possible failure of the roofing material or guttering.

Where practicable, the entire installation should be cleaned down with a blower vac, swept, or alternatively, if a water supply is available, hosed down at the completion of the work to remove paint and render etc. This has not been the case to areas observed. There are also areas presenting with scratches and general dints and damages. As per documented photos areas will need to be properly rectified or roof sheeting/ flashings be replaced.

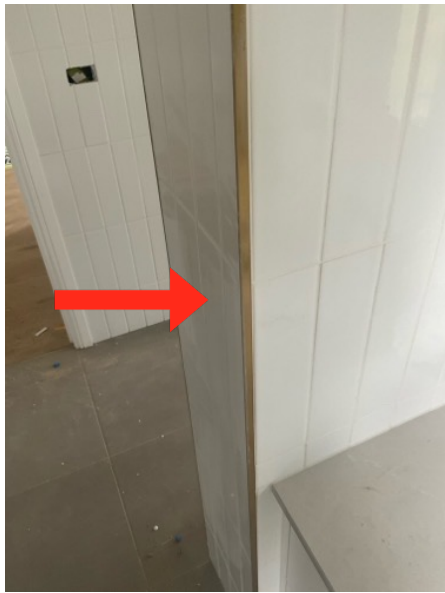
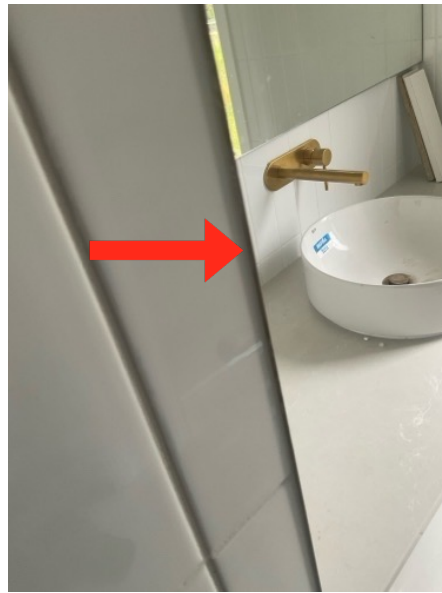
## Defect 1.49

2/ The noted tile trims exceed the wall line. As per AS 3958.1, lippage must be restricted to 1 mm maximum. We detected tiles that need to be reworked as the lippage exceeds this allowance. Any tile with a lippage that is greater than 1 mm must be reworked.

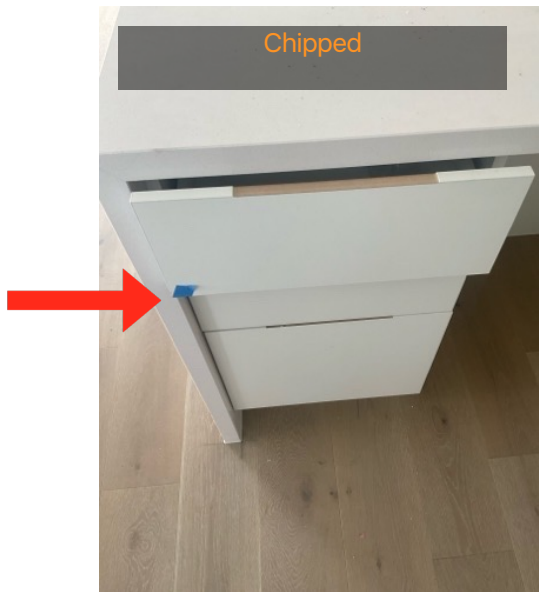
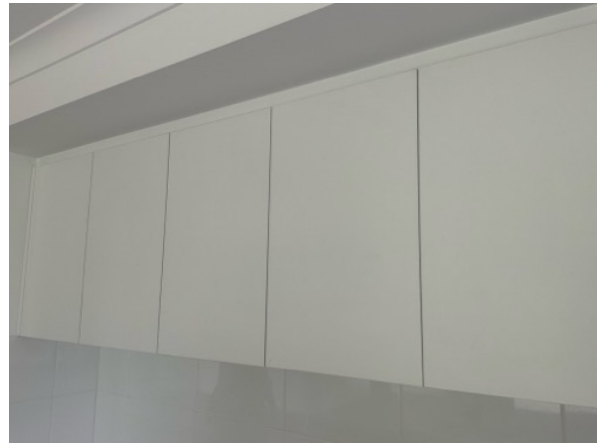
## Defect 1.50

Where the time limit for defects in bench tops, cabinet doors, drawer fronts and similar joinery is not documented, it is to be taken as six months from completion.

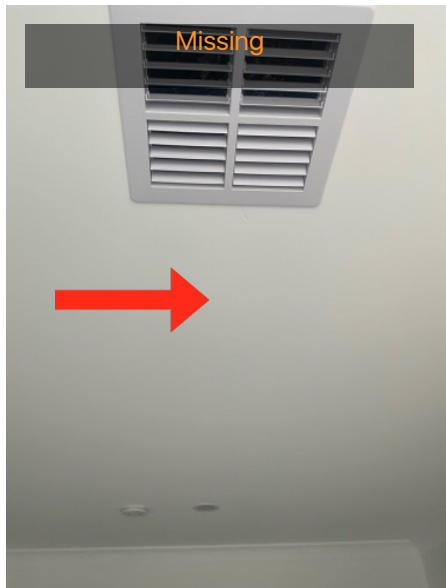
### Incomplete Works 2.01

**Finding:** Down light missing

The construction drawings show a down light to be installed as per electrical drawings. Down light incomplete at time of inspection.
