# New Home Building Inspections

## Pre Handover

Inspection Date: 2 Feb 2024

Property Address: 26 Not Fit For Handover Dream Suburb 44444

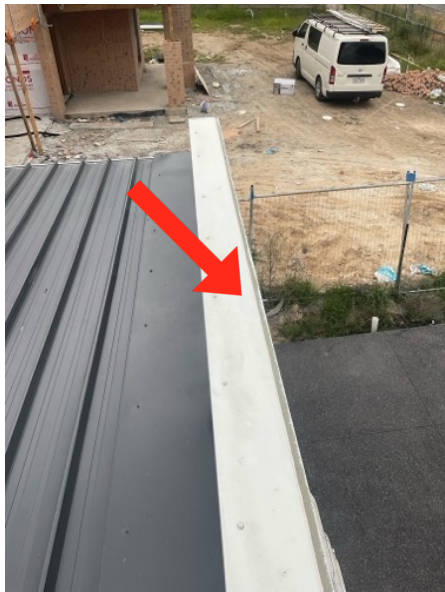
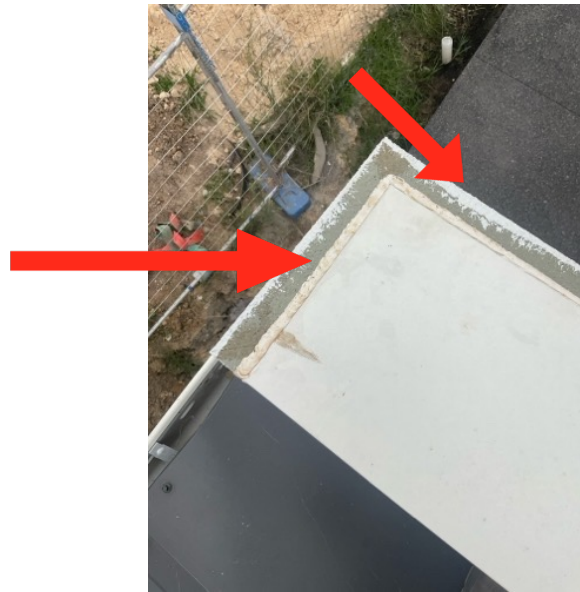
## Non compliant 3.01

The current configuration is reliant on sealant that will deteriorate overtime.
