# New Home Building Inspections

## Pre Handover

Inspection Date: 2 Feb 2024

Property Address: 26 Not Fit For Handover Dream Suburb 44444

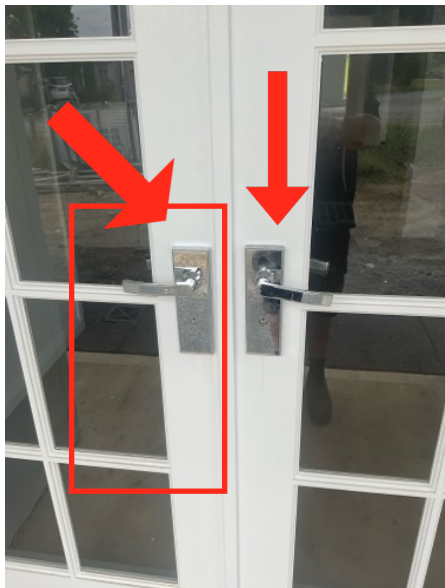
**Finding:** Door furniture (handles)

Poor installation observed, areas misaligned, door damaged to right side requires replacement. During the documented maintenance period after completion, handles, locks and latches are defective if they do not operate as intended by the manufacturer. If the maintenance period is not documented, three months is the assumed time period after completion. After the end of the maintenance period, failure is not a defect unless it is caused by the builder's workmanship or a faulty product supplied by the builder.

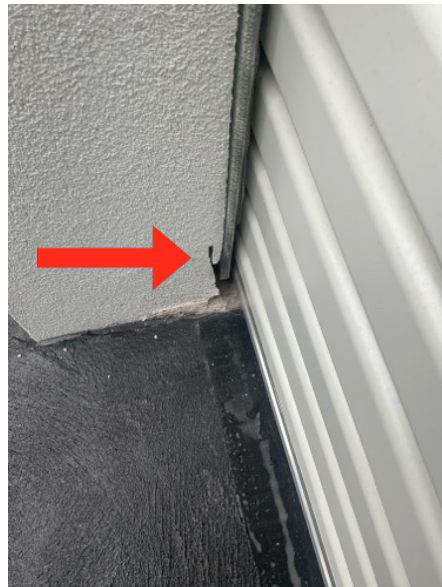
Some substandard practices observed to the exterior render of this home, The general render has not been applied in accordance with the contract documents, which looks poorly finished, and detracts from the overall finish.

The Victorian Building Authority's Guide to Standards and Tolerances clause (9.09) Rendered surfaces, states that Rendered or hard plastered surfaces are defective if they do not conform to the documented surface, sample or description.

In order for the builder to reach completion, they must have completed the works in a proper and workmanlike manner and in accordance with the plans and specifications. Therefore, these areas must be rendered to match the contract documents in accordance with above. Photos added below show some areas for rectification works. The entire property should be checked by the builder.

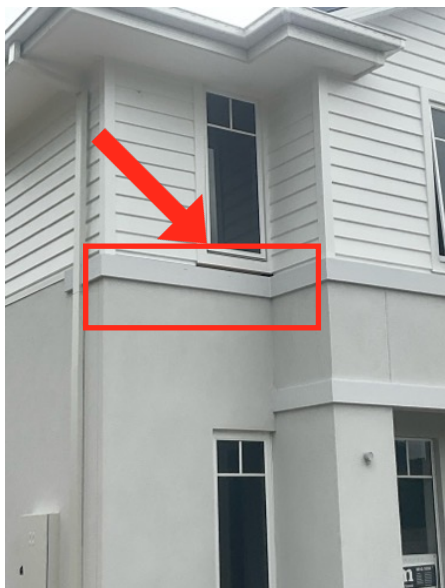
**Finding:** Weatherboards incomplete .

Some weatherboards are not installed excessive gaps noted.  
There is a noticeable gap to the underside of the window.  
Generally the area is incomplete.

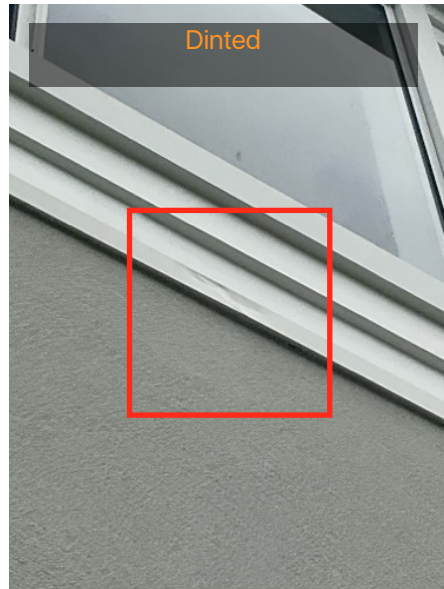
**Finding:** Flashing repairs required ( damaged)

The flashings are showing signs of damage in areas.  
Gutters and downpipes and general flashings are defective if they are not securely fixed or misalignment or damage can be seen from normal viewing position. As per documented photos below area requires replacement.

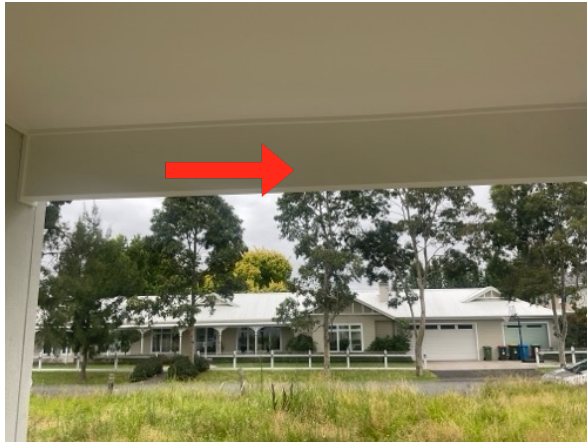
The Building Commission's Guide to Standards and Tolerances clause 12.04 Mechanical Damage and Natural Defects in Surfaces, states 'Holes and any other unfilled depressions in paint or stained timber such as surface defects caused by mechanical damage, natural characteristics such as gum pockets or surface splits are defects if they can be seen from a normal viewing position'. A normal viewing position would be at a distance of 1.5 metres or greater back from these beams.

The splits and holes along these beams need to be properly filled before being properly sanded and repainted prior to handover proceeding.

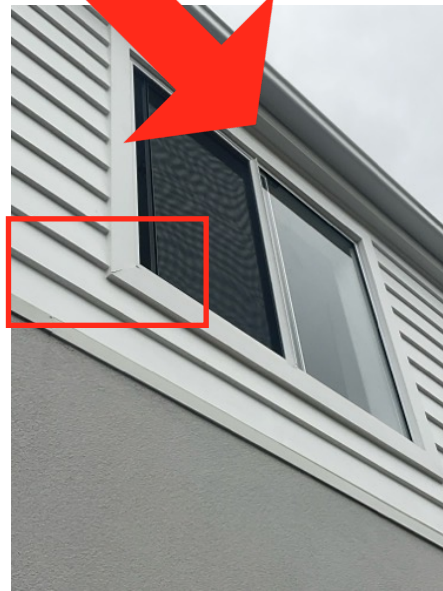
(17.3. )The guide to standards and tolerances 2015,10.02 Joints in fixings and mouldings states:

“Unless documented otherwise, the faces of architraves and skirtings are defective if they are not aligned and flush at mitres and butt joints and the misalignment can be seen from a normal viewing position. (These areas will require rectification.)

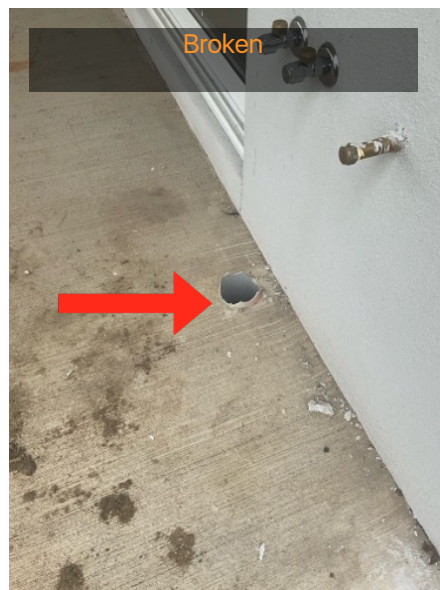
**Finding:** Damaged pipe's requiring repair and recapping

The PVC pipes to various locations have been damaged or uncapped. These will require repair and recapping to prevent debris blocking the pipes during the construction process. Noted areas blocked with mulch etc.

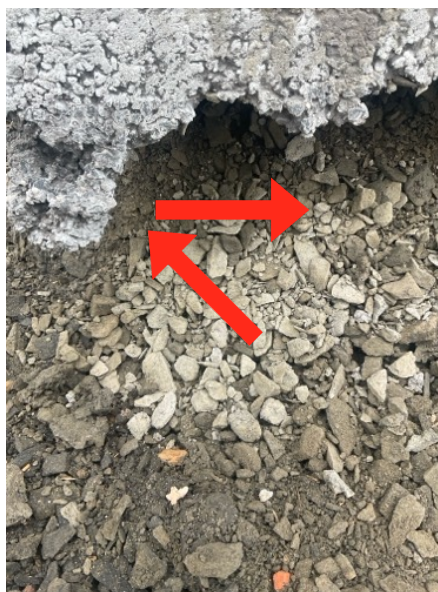
**Location:** The site  
**Finding:** Concrete observed.

While it is not possible to confirm the site preparation of works undertaken by the Builder prior to pouring, the sub-base to the driveway area. While appearing adequate for typical lightweight residential construction, it should be to the requirements of AS3727.1 2016. Noted areas not achieving 100mm. Some areas appear to have little or no support.

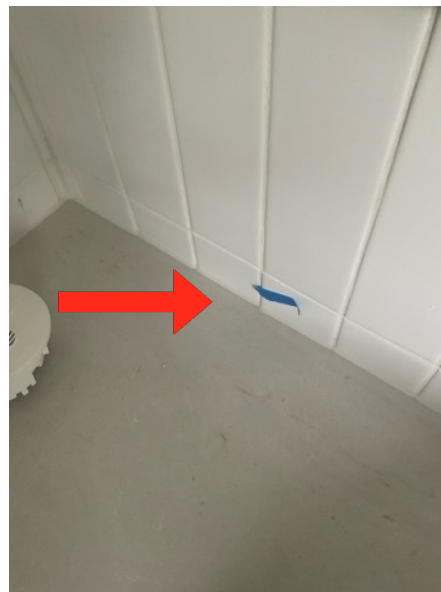
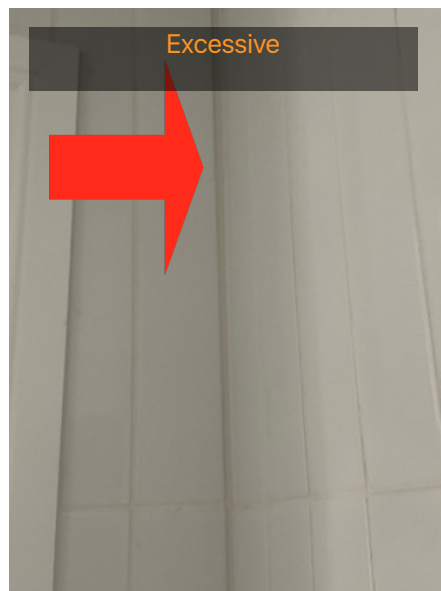
When measured with a straightedge, tiling is defective if the finished surface of the tiling is not flat and true to within a tolerance of  $\pm 4$  mm in 2m from the required plane.

Tiling is defective if the lippage between two adjacent tiles exceeds 2 mm. In the case of tiles where the surface has been ground flat, for example polished tiles, tiling is defective if the lippage exceeds 1.5 mm; for joint widths of 3 mm or less the lippage should not exceed 1 mm.

As per AS 3958.1, lippage must be restricted to 1 mm maximum. We detected tiles that need to be reworked as the lippage exceeds this allowance. Any tile with a lippage that is greater than 1 mm must be reworked

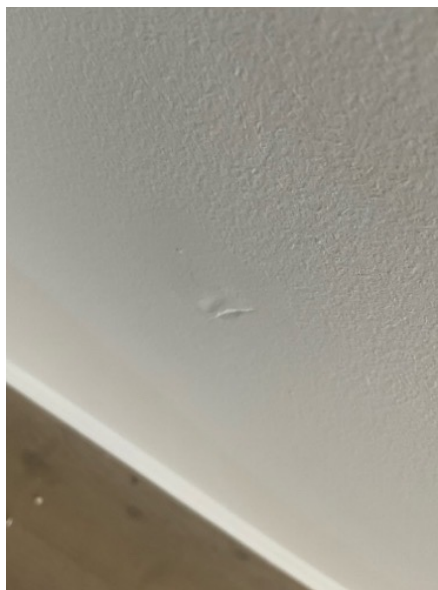
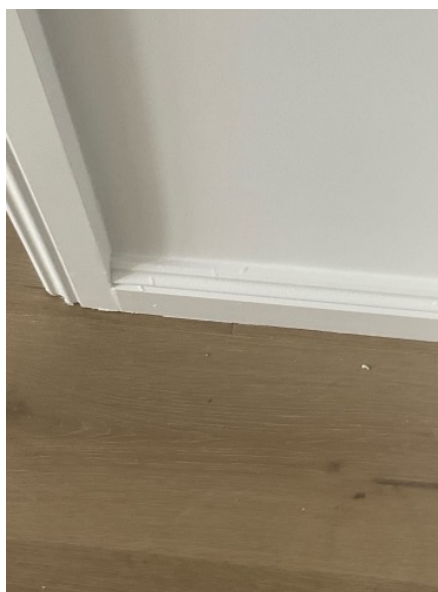
There are numerous minor paint defects such as runs, bare areas, cracks, marks and other irregularities that need to be rectified throughout, too many to individually document in this report.

The Victorian Building Authority's Guide to Standards and Tolerances clause 12.02 Surface Finish of Paintwork, states Paintwork is defective if application defects or blemishes such as paint runs, paint sags, wrinkling, dust, bare or starved painted areas, colour variation, surface cracks, irregular and coarse brush marks, sanding marks, blistering, uniformity of gloss level and other irregularities in the surface are visible from a normal viewing position.

All of these areas will need to be properly rectified and re-painted.

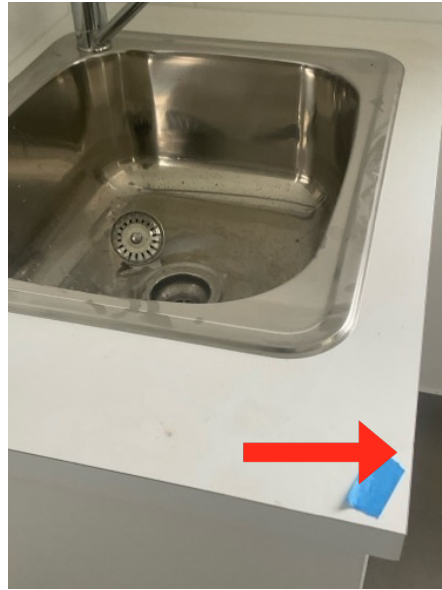
Area as per documented photos, defective. Materials are defective if they are cracked, pitted, chipped, scratched or loose at handover.

Noted chip to bench top.

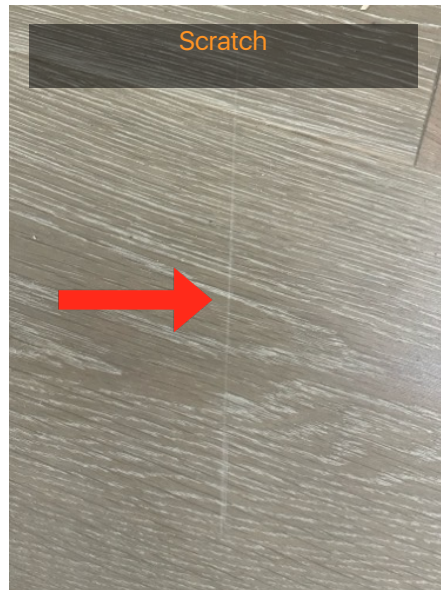
Cracked, pitted, chipped, scratched surfaces

Noted floor not clean at time of inspection. Noted scratches observed to surface.

Surfaces are defective if they are cracked, pitted, chipped, scratched or loose at handover.

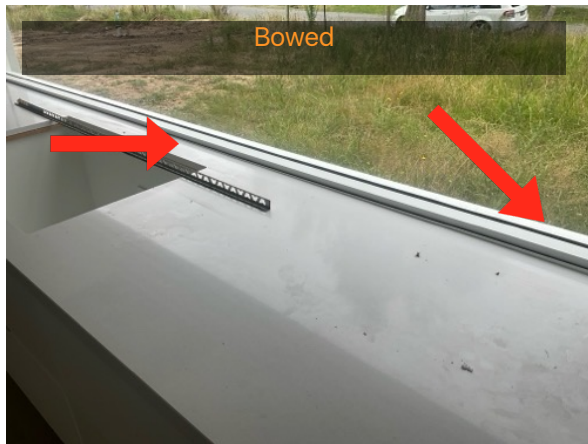
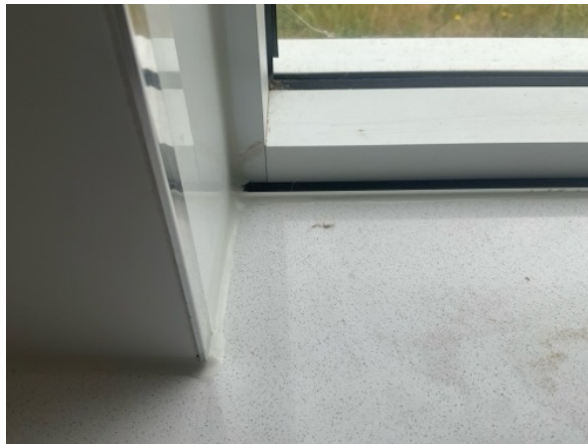
In this case the defect in discussion is windows are bowed .

7.3.1 General A gap shall be provided between the window and the surrounding structure sufficient to prevent loads being imposed on the window, allowing for thermal expansion

ALL WINDOWS should be installed as per manufacturers standards is packing to the sides and bottom of the windows as well, must be reworked to allow a recommended of at least 15mm to 20mm of packing.

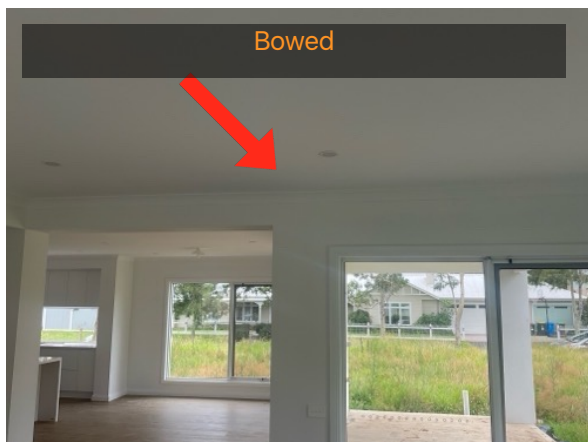
**Finding:** Straightness and alignment of plaster cornices

The cornice ceiling line bowed to, section as per documented photos below.  
( AS PER ALL PREVIOUS REPORTS.) Plaster cornices are defective if they deviate from a straight line greater than 4 mm over a length of up to 2 m and are visible from a normal viewing position. There is a sag of up to 10mm in the ceiling and cornice lines across the area which is also noticeably out of parallel to the horizontal edge of this area which for the reasons detailed above will need to be properly straightened and the affected areas repaired.

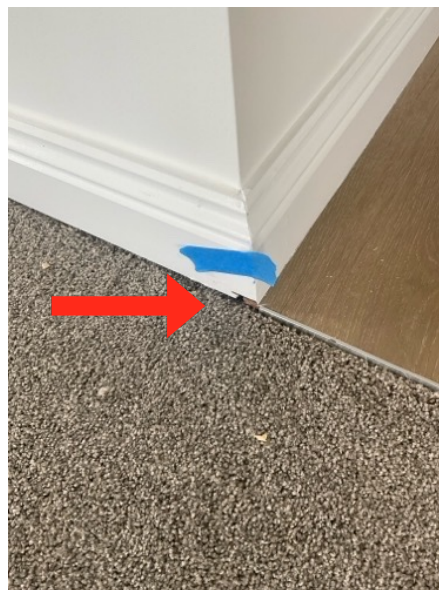
(17.3. )The guide to standards and tolerances 2015,10.02 Joints in fixings and mouldings states:

"Unless documented otherwise, the faces of architraves and skirtings are defective if they are not aligned and flush at mitres and butt joints and the misalignment can be seen from a normal viewing position. These areas will require rectification.

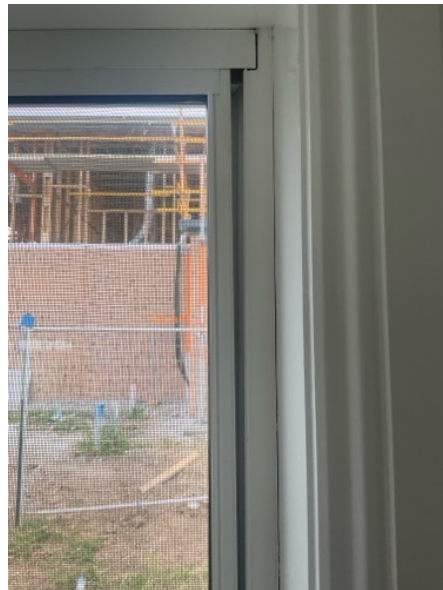
The noted sill section is bowed as per documented photos. Bowed window heads, sills and jambs

Windows frames are defective if they are distorted to the extent that the function of the window is adversely affected.

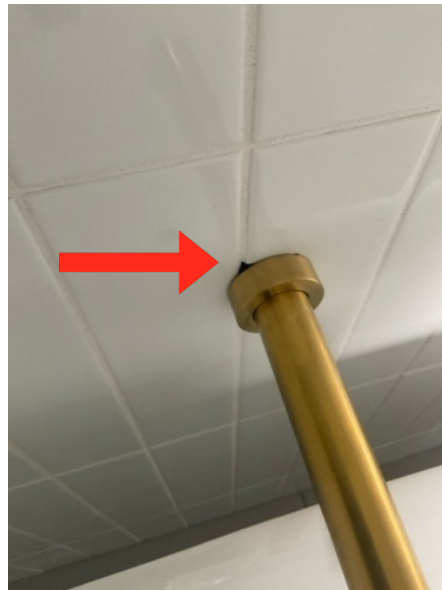
**Finding:** Overcut tiles observed to wall lines.

If any tile is chipped, cracked, scratched or loose prior to the handover of the property the tile/s or tiling is considered defective. Noted tiles over cut to plumbing fixtures.

Tiles are defective if they are cracked, pitted, chipped, or scratched or loose at handover.

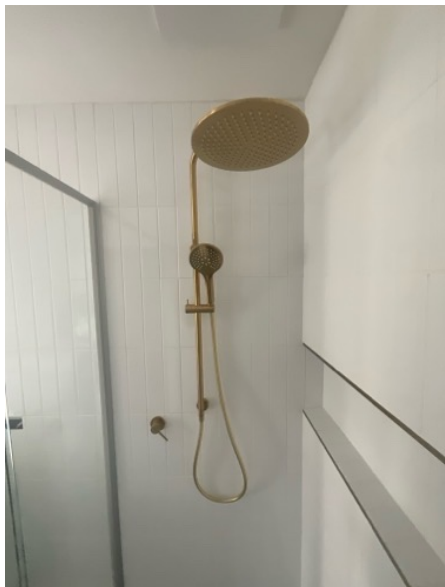
**Finding:** Misaligned shower rail

The shower fixture to this area is installed out of plumb. The general fixture requires rework.

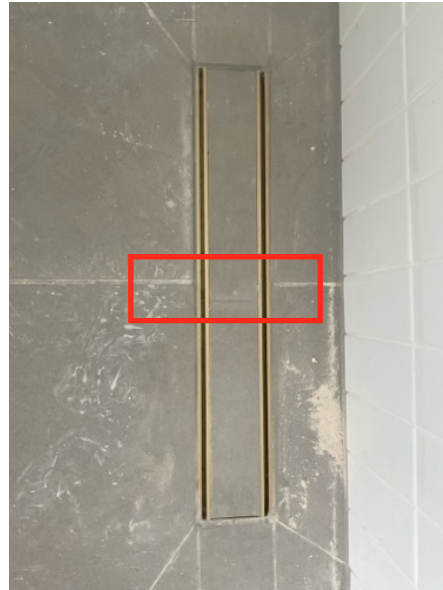
The noted tile lines to shower waste do not line through, and are inconsistent. See photos below. Noted shower screen incomplete at time of inspection.

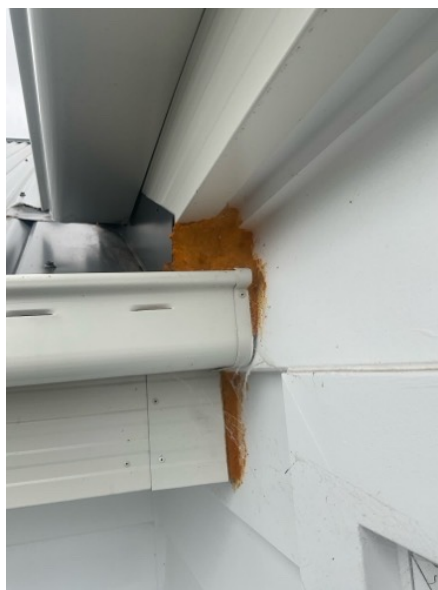
Flashing pieces require rectification.

Areas that are frequently exposed to harsh weather conditions require adequate protection in order to maintain their condition. The pieces to the sections as per documented photos is non compliant or finished adequately, general deterioration is likely to occur at an accelerated rate. If left unattended, water penetration is likely in the short-term future. Adequate flashing will be required to be installed as soon as possible.

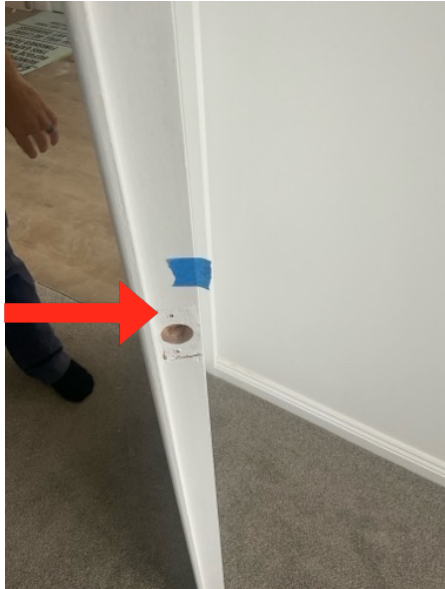
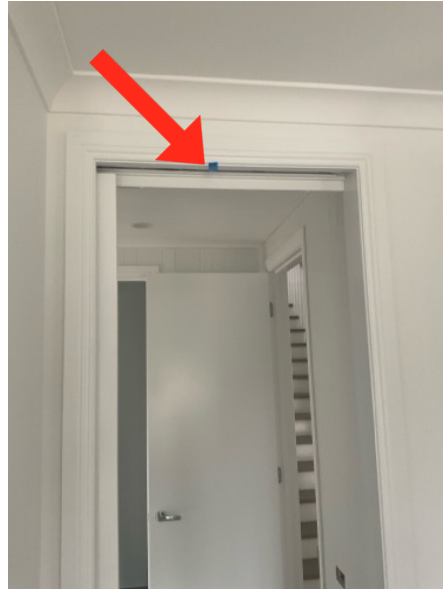
**Finding:** General

Incomplete works at time of inspection as per documented photos .

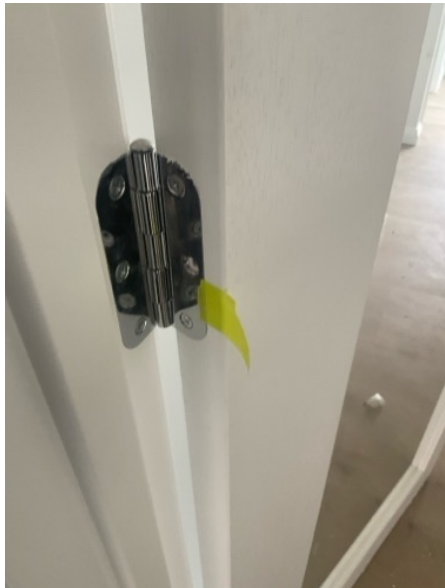
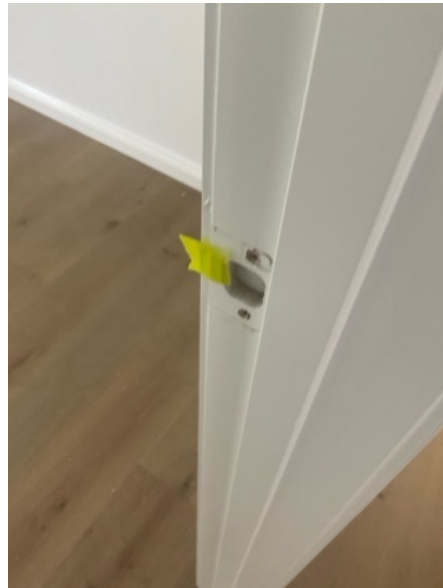
**Finding:** Hinge pins and screws to hinges.

It's recommended all internal hinges to be checked prior to the handover of this home. Hinge pins require rectification in some areas some areas require screws as per documented photos.

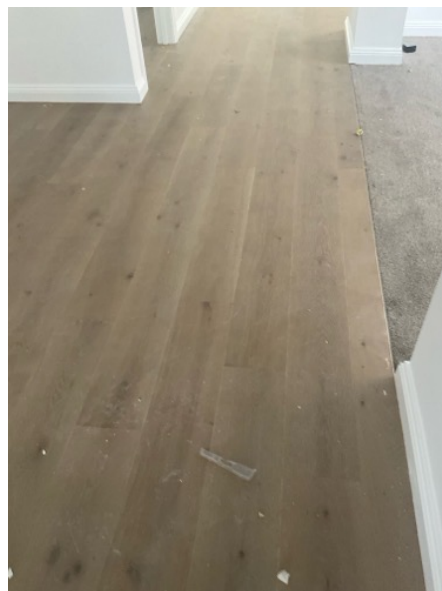
Photos are provided for your general reference.

Once the cleaners have properly completed all of this work, all of the glazing, mirrors, cupboards, baths, shower bases, shower screens, floor coverings, fixtures and fitting etc. should all be thoroughly checked again for any scratches and damage which may have occurred, prior to handover proceeding.

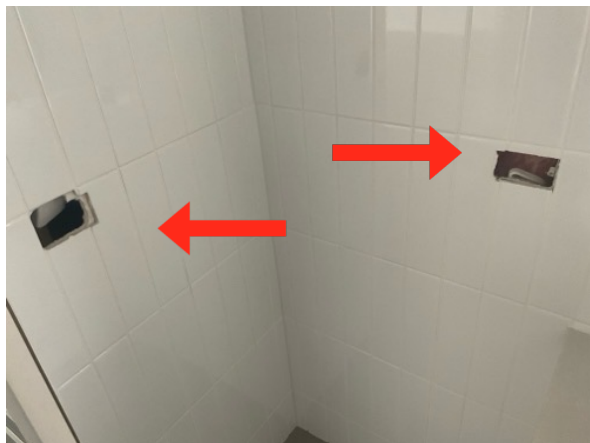
**Finding:** Electrical system incomplete

General areas require rectification. (this was not checked). This can become a safety hazard if live wires are exposed. It is recommended for a licensed electrician to conduct an assessment of the electrical works and rectify where necessary.
